SURVEY REPORT #844M11

Vessel Name: "COUNTERPOINT"

Type: Auxiliary Sail

Purpose of Survey: Condition and valuation for pre

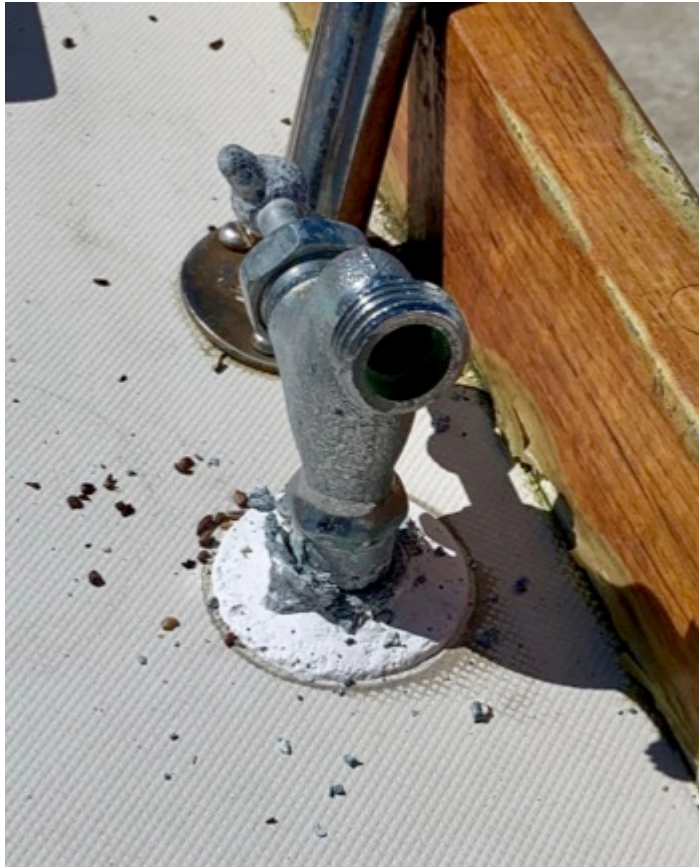
Deteriorated deck wash spigot thru deck fitting

19. Prove operation of the fwd shower sump pump.
20. Consider replacement of the air con compressor.
21. Suggest replacement of the deck washdown spigot and thru deck fitting on the foredeck.

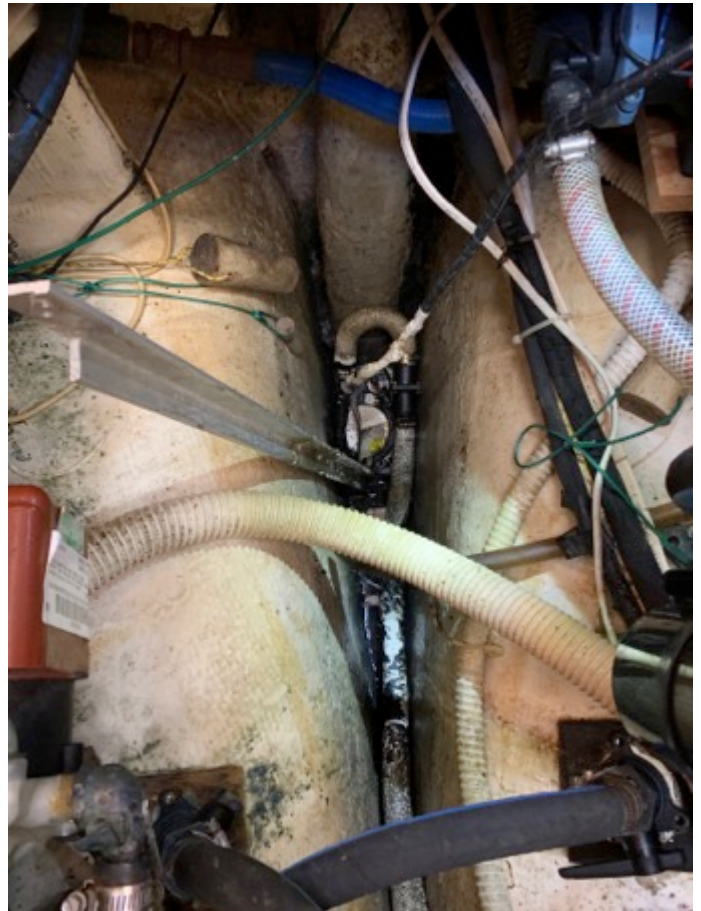
Deep bilge; black oily residue at the bottom

7. Recommend steam or power washing the deep bilge to eliminate the oily waste.
