SURVEY REPORT #844M11

Vessel Name: "COUNTERPOINT"

Type: Auxiliary Sail

Purpose of Survey: Condition and valuation for pre

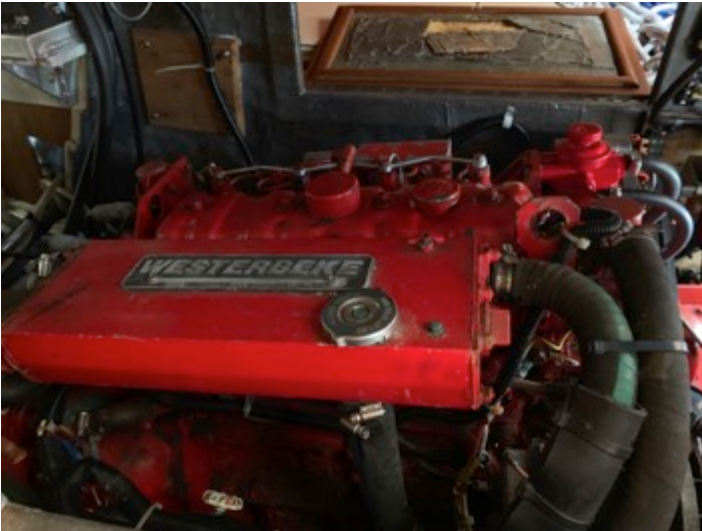
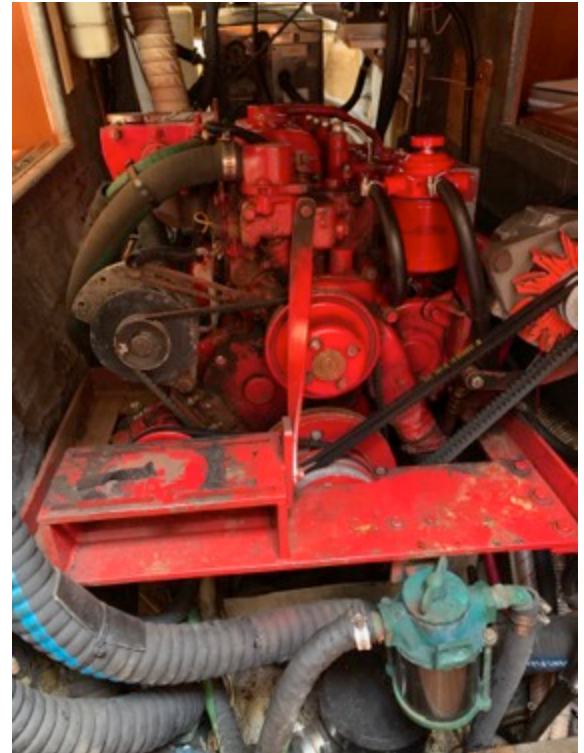
General Condition: Inspected visually. Engine hours as seen on the meter are much to low for the age. An engine examination by a qualified diesel tech is planned. The structure in front of the engine appears to be left from an earlier mechanical engine driven refrigeration compressor (*Note*)

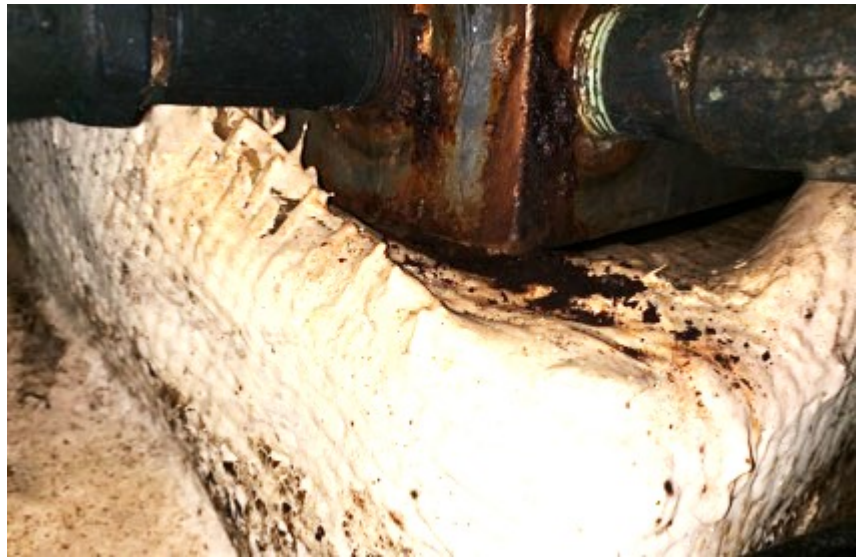
Thru-Hull Fittings/Valves: Bronze barrel valves on all fittings except two Marelon ball valves aft. External inspection of the through-hull fittings revealed all to have from moderate to heavy oxidation. All Bronze valves show some degree of galvanic or electrolytic corrosion.
(Note)

Condition: All Bronze valves found frozen, the engine intake fitting at the valve is weak and appears to leak (Note)
